Load Fatigue Performance of Four Implant-Abutment Interface Designs: Effect of Torque Level and Implant System

H. C. Quek, BDS, MDS, MRD, RCSEd¹/Keson B. Tan, BDS, MSD²/Jack I. Nicholls, PhD³

Key words: abutment screw failure, implant-abutment interface, load fatigue, preload, torque

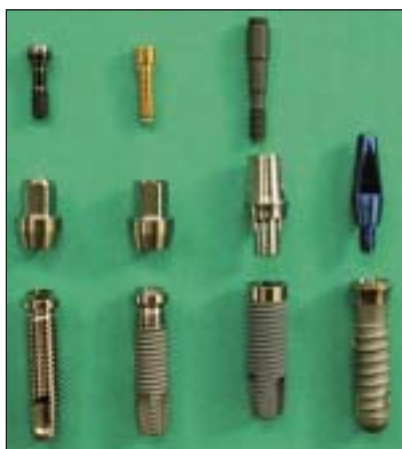
Fig 1a Components of 4 implant systems tested. (From left) Brånemark MkIII RP implant with CeraOne abutment and TorqTite screw; 3i standard Osseotite implant with STA abutment and Gold-Tite screw; Replace Select TiUnite RP implant with Easy abutment and TorqTite screw; and Lifecore RBM Single-Stage implant with RDS COC abutment.

The 4 implant-abutment systems used are described in Table 1 and shown in Figs 1a and 1b. The same operator performed all sample preparation and testing, which was done in random order.

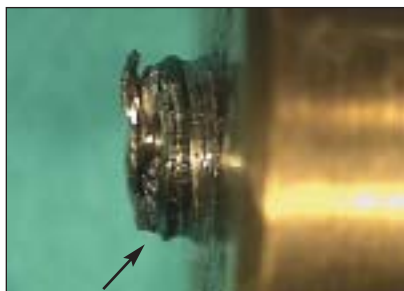
Fig 4a Implant fracture at the first thread (arrow). Sample BR/4/0.

Three of the 15 samples failed. There were 2 implant fractures and 2 TorqTite abutment screw fractures. For implant failures, sample BR/1/0 fractured apically at the level where the self-tapping threads began (Fig 3), and sample BR/4/0 fractured at the commencement of the threads (Fig 4). The TorqTite abutment screw of this specimen also fractured at a level slightly below the implant fracture level. The TorqTite abutment screw of sample BR/4/+ fractured at the first thread region (Fig 5). None of the test samples in the -20% recommended torque group failed.

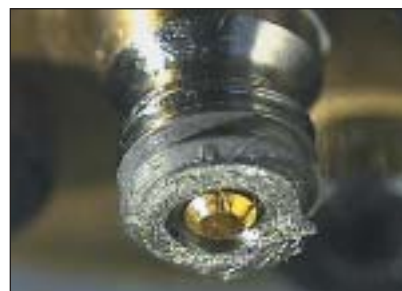
Fig 6a Fracture of implant at the third to fourth thread region. Gold-Tite screw not involved. Sample 3i/4/0.

There were 9 failures among the 15 samples tested; 4 implant fractures and 5 abutment screw fractures. In the 4 cases where the implant failed, the fractures did not involve the abutment screw (Fig 6a). All the 5 samples in the group where -20% recommended torque was applied had abutment screw fractures that left the implant intact. The 4 implant failures were distributed equally between the other 2 torque groups. SEM of these 4 implant failures revealed fatigue striations (Figs 6c and 6d).

In the 3i system, all 4 implant failures occurred at the third thread, which coincided with the apical extent of the abutment screw when fully seated. All abutment screws were intact, and the implant-abutment interfaces were maintained at the point of implant fracture. It is noteworthy that the fractures occurred at the implant level which corresponded to the thinnest cross section due to the internal threading (Fig 6b). It appeared that if the Gold-Tite abutment screw did not fail first, the applied stress concentration would be focused on this location, leading to implant fatigue failure.

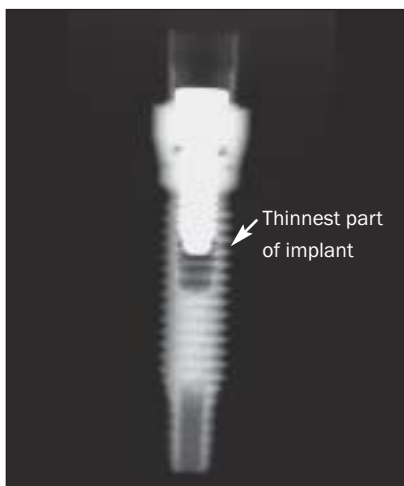
Fig 6b (Left) Radiograph of the 3i implant system.

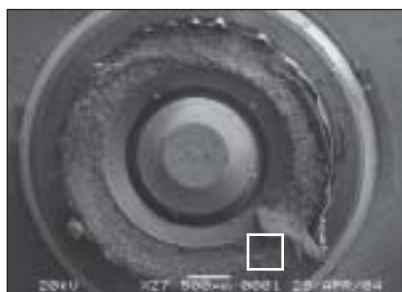
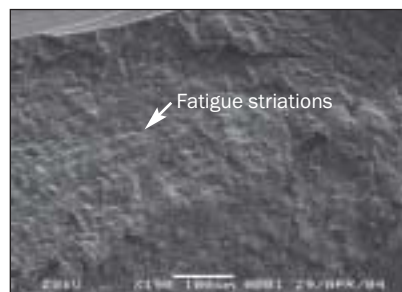
Fig 6c (Above) SEM of failed implant at the third to fourth thread region.

Fig 6d SEM of boxed area in Fig 6c at higher magnification showing fatigue striations. Sample 3i/4/0.

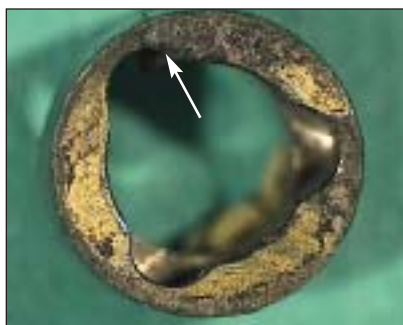
Fig 7a Crack at thinnest section of internal configuration. Sample RS/3/0.

Fig 7b SEM of the side of the fractured implant. Sample RS/3/0.

There was 1 failure among the 15 samples tested. The coronal aspect of the implant in sample RS/3/0 fractured and separated from the main implant body. A crack was noted at the thinnest wall portion at one “channel” of the tri-channel internal configuration, which seemed to have propagated apically to the root of the implant threads and caused failure (Figs 7a and 7b). The TorqTite screw of the same sample also fractured at the screw shank.

For the 1 sample failure in the Replace Select system, both the implant and screw fractured. Crack initiation probably occurred at the thinnest aspect of the tri-channel implant internal configuration and led to implant and screw fracture. Inspection of the internal aspect of the Replace Select internal connection revealed a blue discoloration (Fig 7c) which was postulated to be the result of the heat generated from the machining of the internal tri-channel configuration leading to possible weakening of the titanium alloy in this location of the thinnest aspect of the implant wall. A finite element analysis study by Nagel et al²⁵ on the lateral load and torsional behavior of internal abutment connections showed that the Replace Select implant may fail by the fracture of the implant body at the thinnest part of the cut-out area. Long-term clinical performance of single-tooth Replace Select implants has not been reported in the literature.

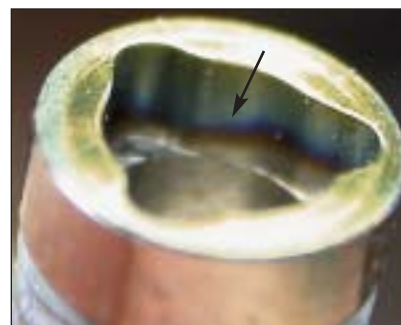
Fig 7c Blue discoloration (arrow) within the internal connection of the Replace Select implant.
